Let's now move on in repairing the ABS sensors and do some maintenance to the handbrake lever. It looks like the front left wheel well had been affected by an engine fire. The engine bay had some melted pipes and it seems that the high temperature affected the ABS sensor insulation. It was melted and I had to find a solution.

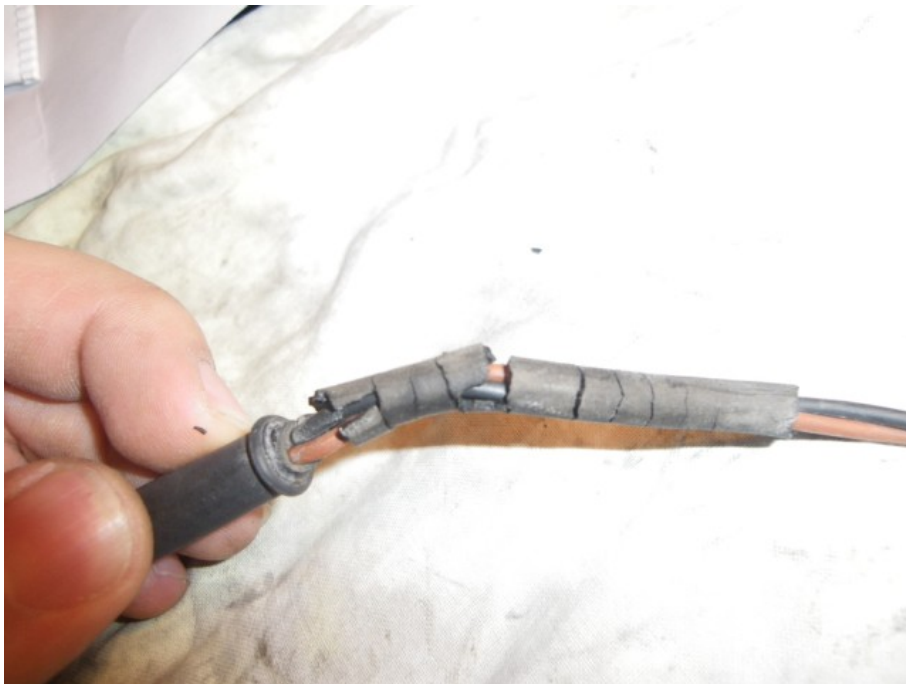
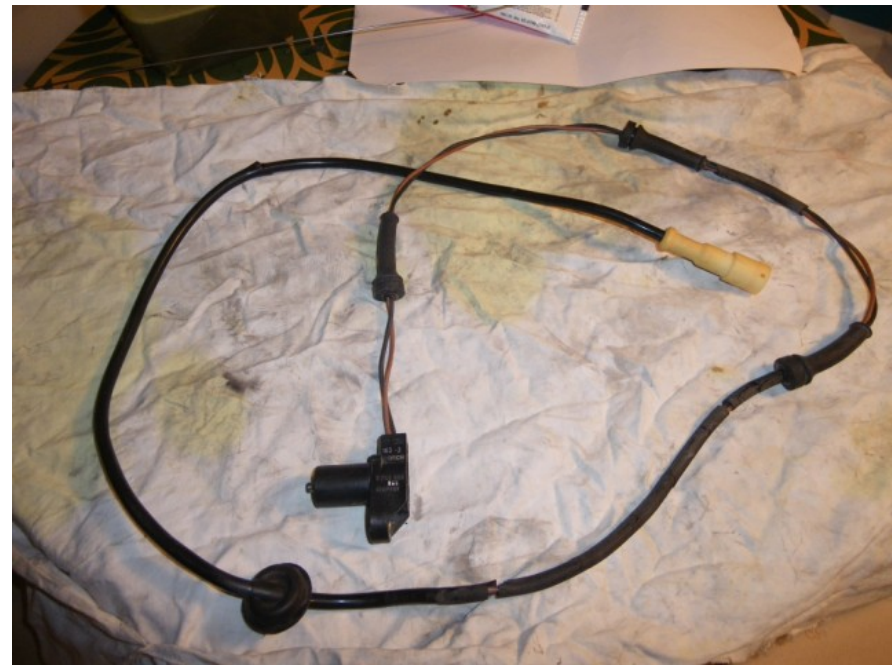
Here you see the rear ABS sensor which clearly has seen better days. The rubber insulation has fallen into pieces and all I can do is remove the perished rubber insulation and replace it with new PVC sleeve.

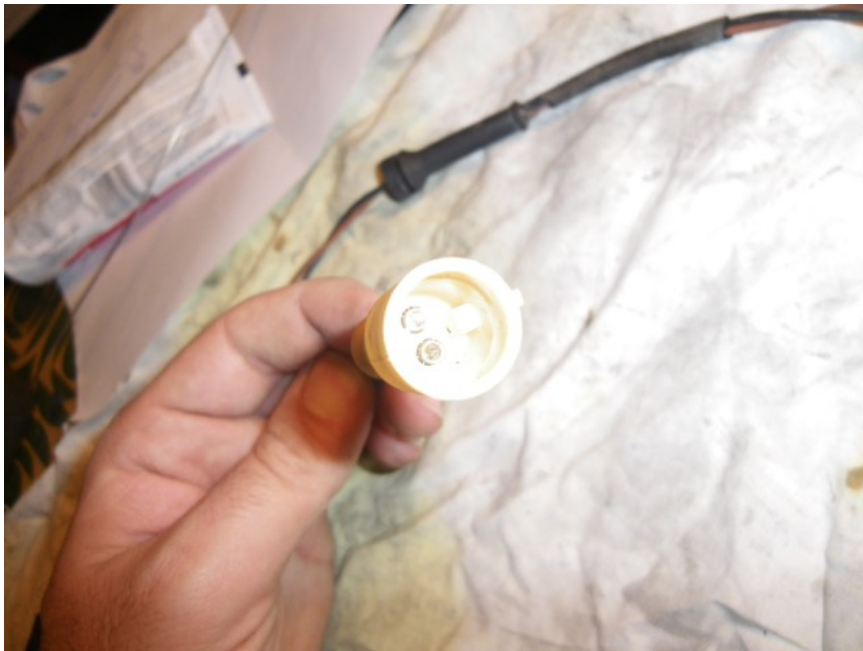
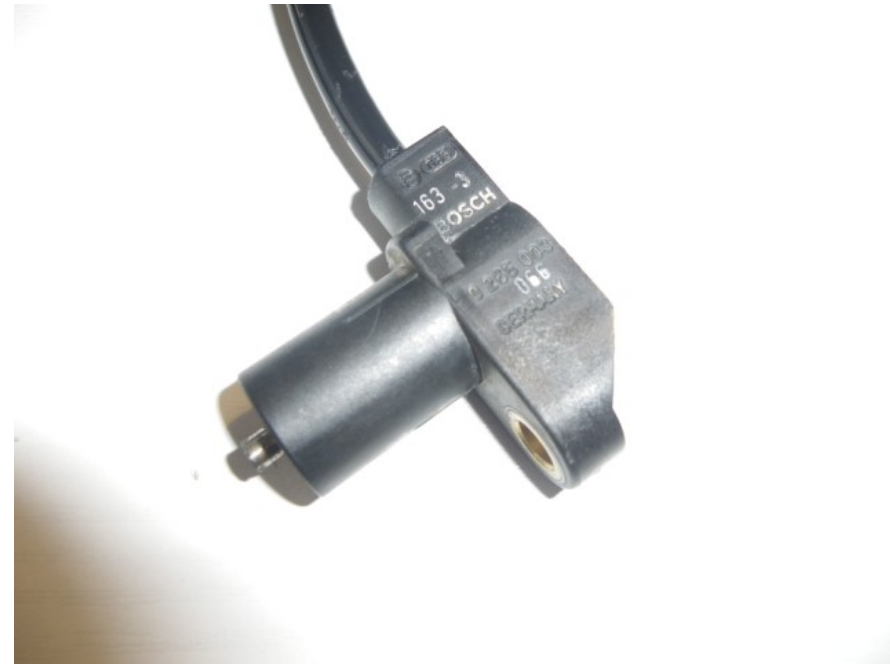
Be sure to clean the connector internals and move away metal shaving from the sensor tip. Metal shavings from the disk brake are attracted by the sensor tip and accumulate there, making sometimes faulty measurements of the wheel speed. This results in faulty ECU interpretation and as a consequence the ABS fault light is illuminated on the instrument cluster.

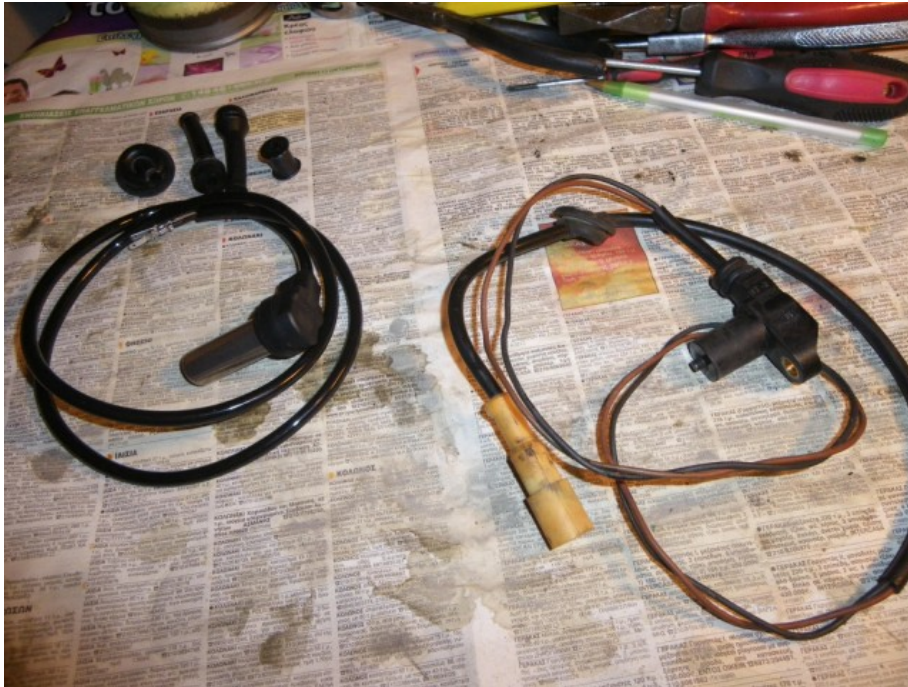
In order to restore the front ABS sensor which had been involved in a fire incident, I bought a FORD sensor off eBay. I used the new sensor wiring which I adopted to the Alfa 33 sensor by preserving the sensor and the connector.

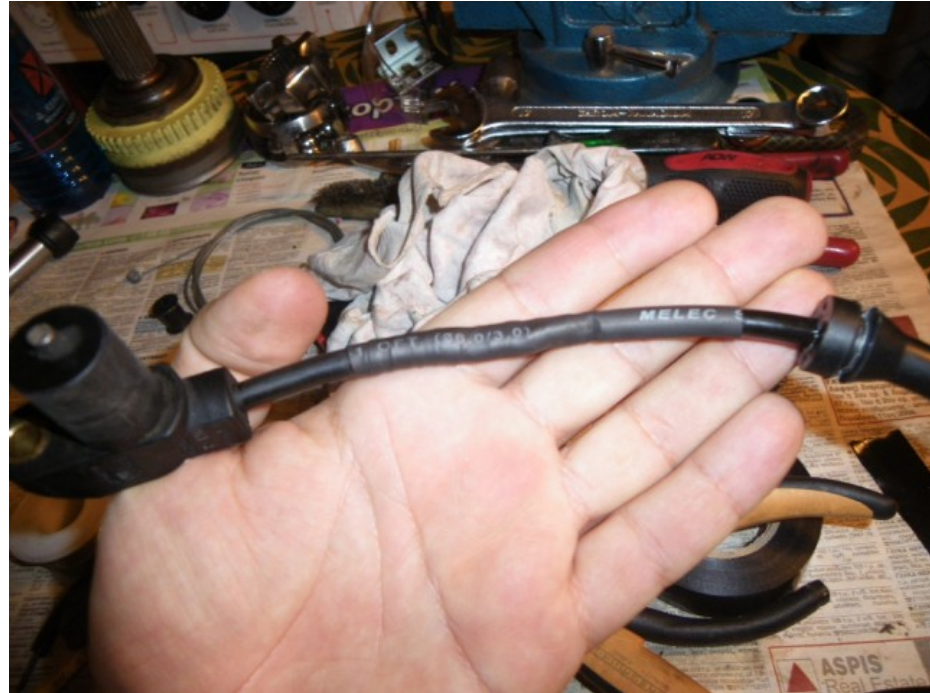
Here is a close-up of the part of the sensor which has been soldered and protected from the weather elements. Heat shrinking tube is used in order to stop anything foreign get inside.

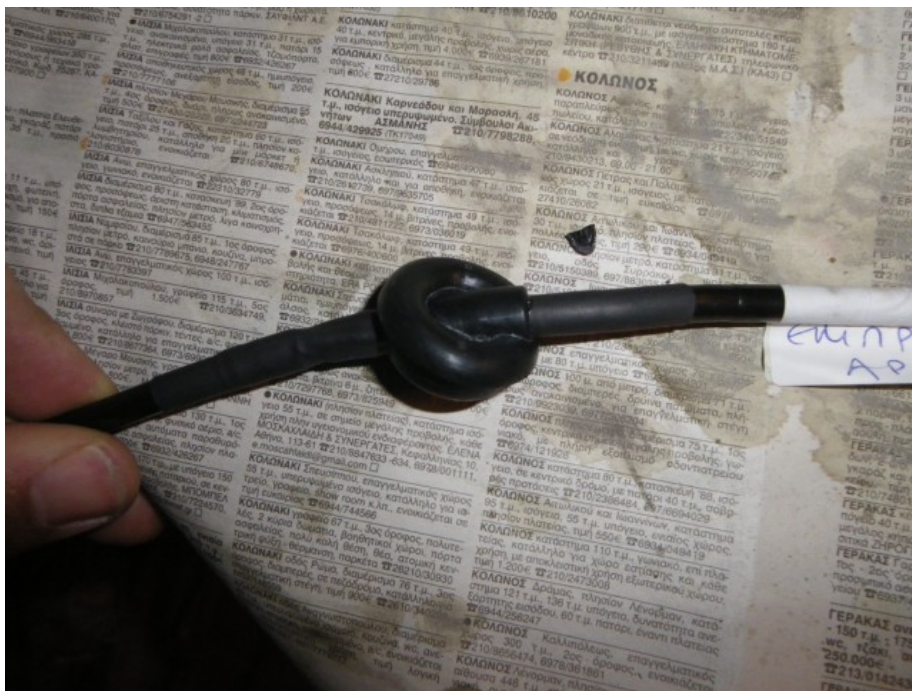
The special rubber grommet off the FORD sensor is used to the Alfa 33 sensor.

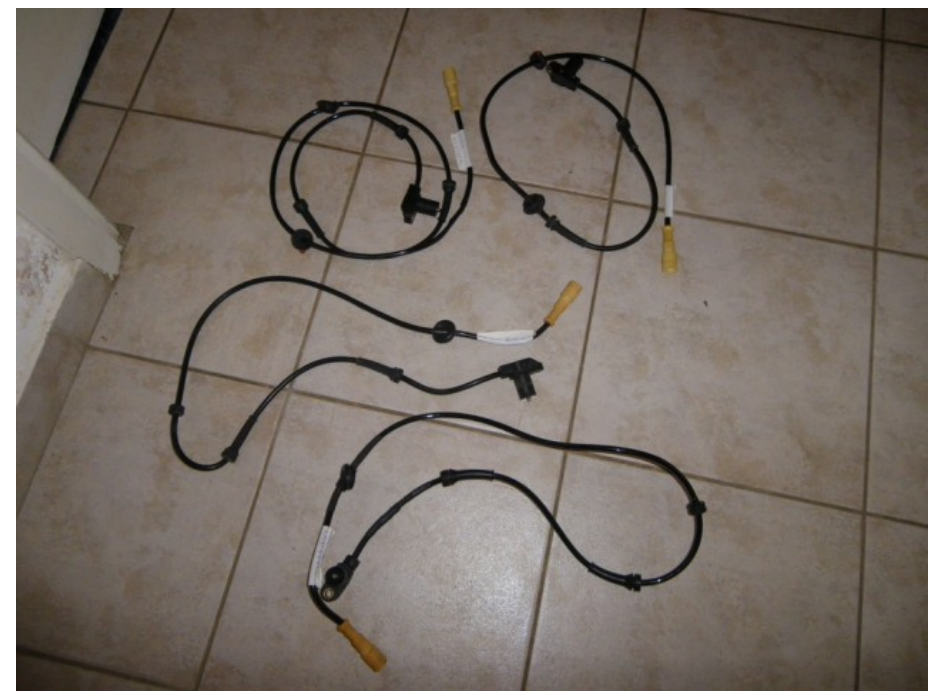
All sensors are now restored and cleaned ready for installation to the vehicle.

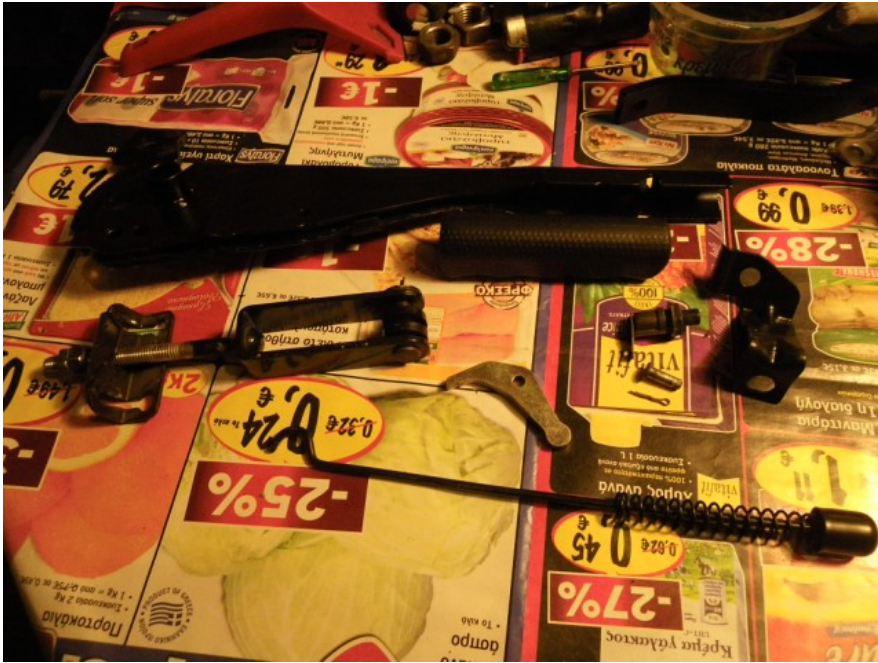
Lets now move on to the handbrake lever. The lever is fully disassembled and checked for wear. I have bought a new lever grip in order to look like new. Freshly powder coated lever and a new grip will surely make a nice fit!

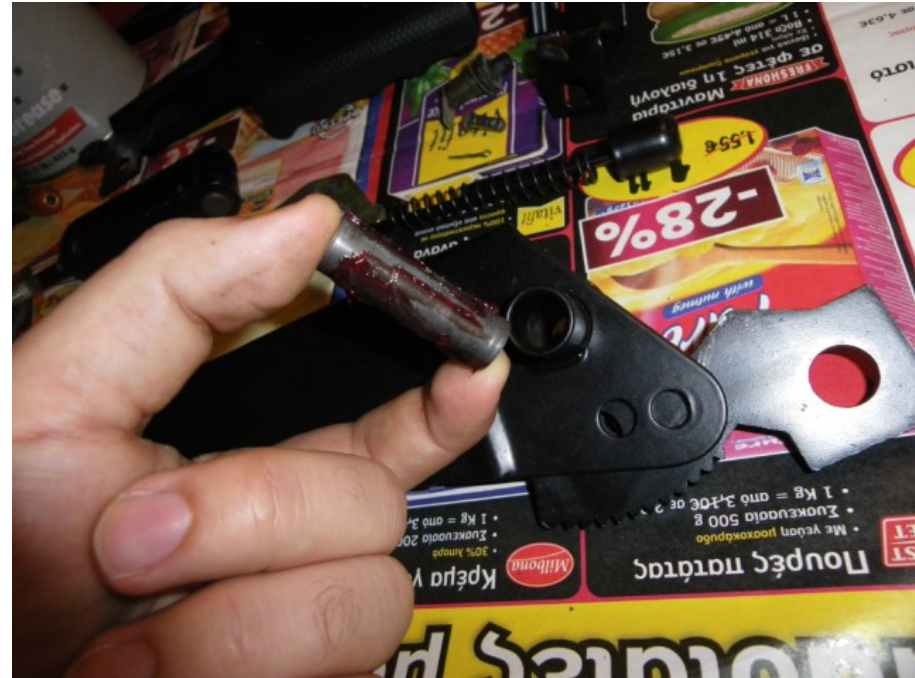
Lubricate the lever pivot pin. Notice on the handbrake lever the two adjacent holes. This is the difference compared to the non ABS handbrake lever. These two holes are there at a specific place in order to provide specific leverage to the handbrake cables in order to lock effectively the rear calipers.

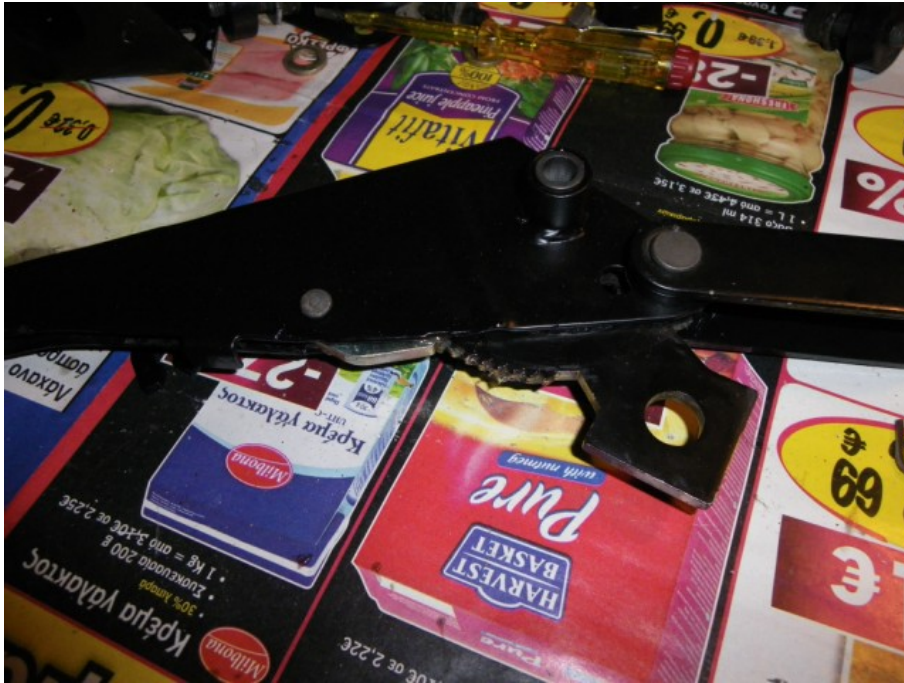
I have used the outer hole as a first approach. However, after the installation I chose to put the lever on the inner hole as it provided better locking of the handbrake.
