Wiring Harness Rebuilt

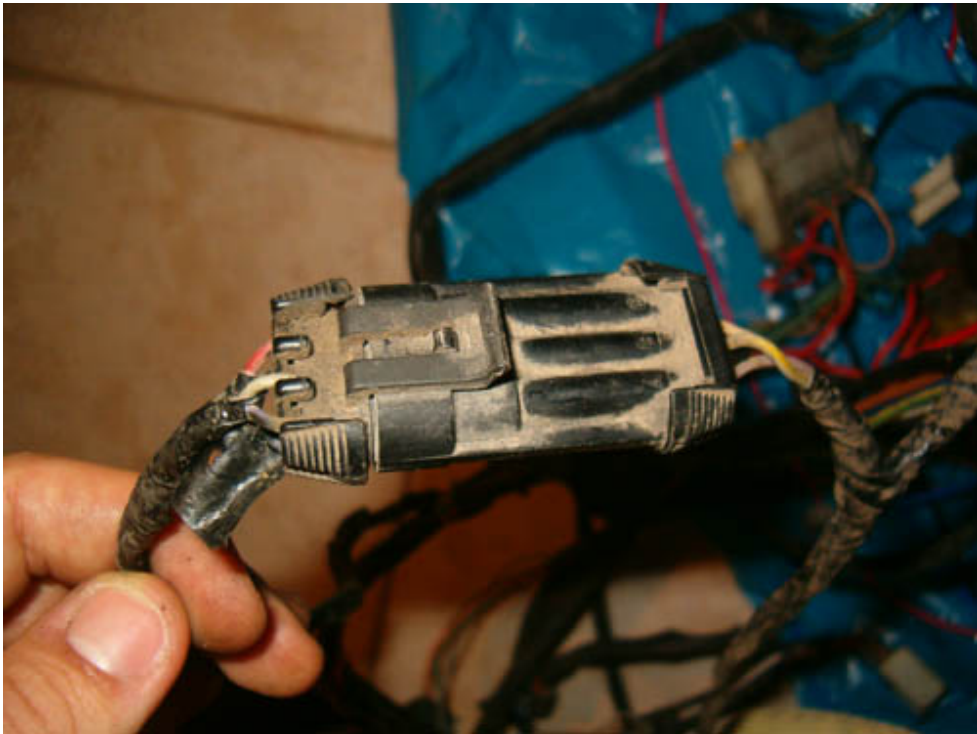
Here is an example of a connector that needed attention. Notice the amount of vinyl tape wrapped around the harness. The moment I got rid of this ugly tape, I found a real mess underneath. Cables were cut, twisted together (not even soldered !), with no insulation (!) and the most dangerous was the fact that some of these cables had melted insulation... This means that during the past a serious electrical fault occurred in the donor car.

Since I am doing a high standards job I decided to rebuilt the harness by using new cables and connectors. These are really cheap and can be found at your local automotive electric shops.

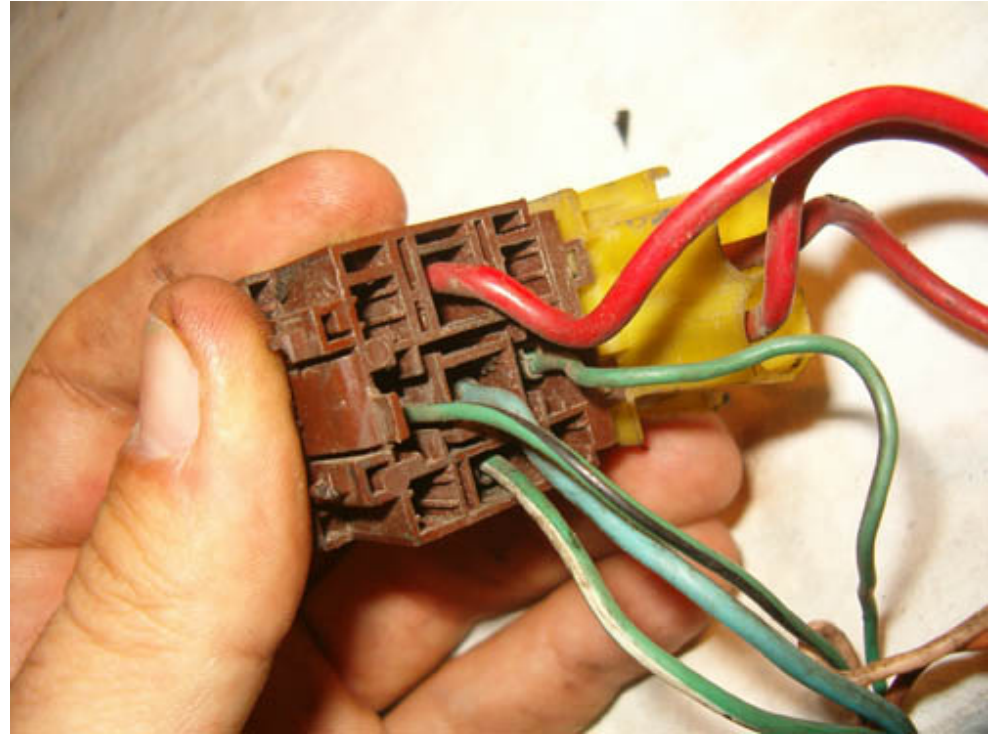
It is not that bad here ...

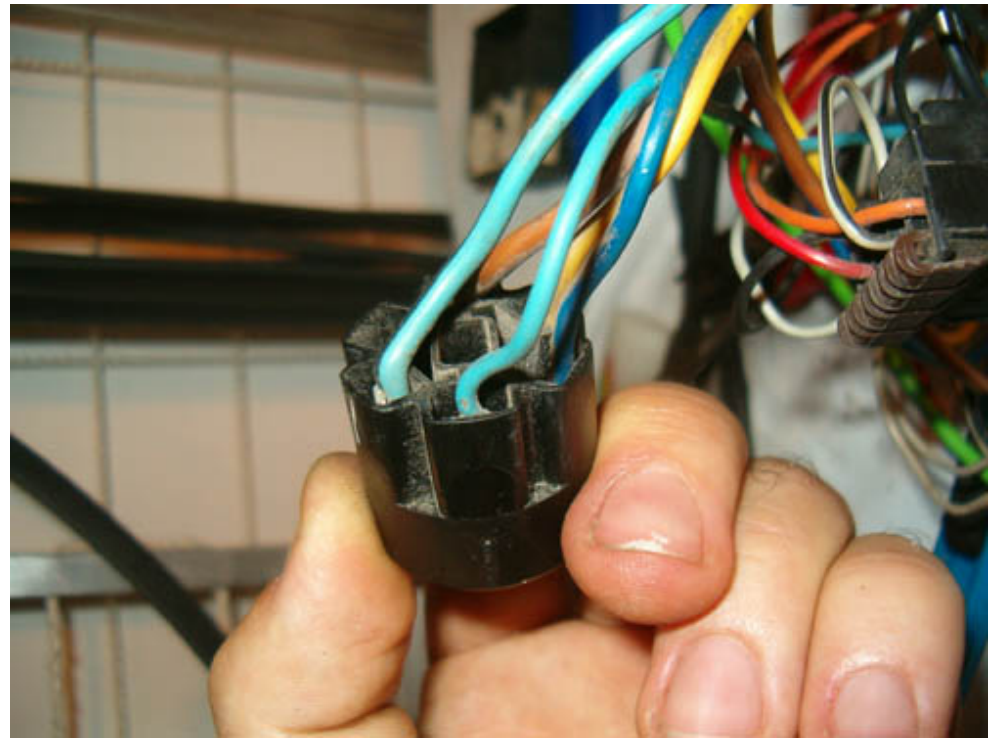
This is the heater fan switch connector. Strange enough there was no fault here.

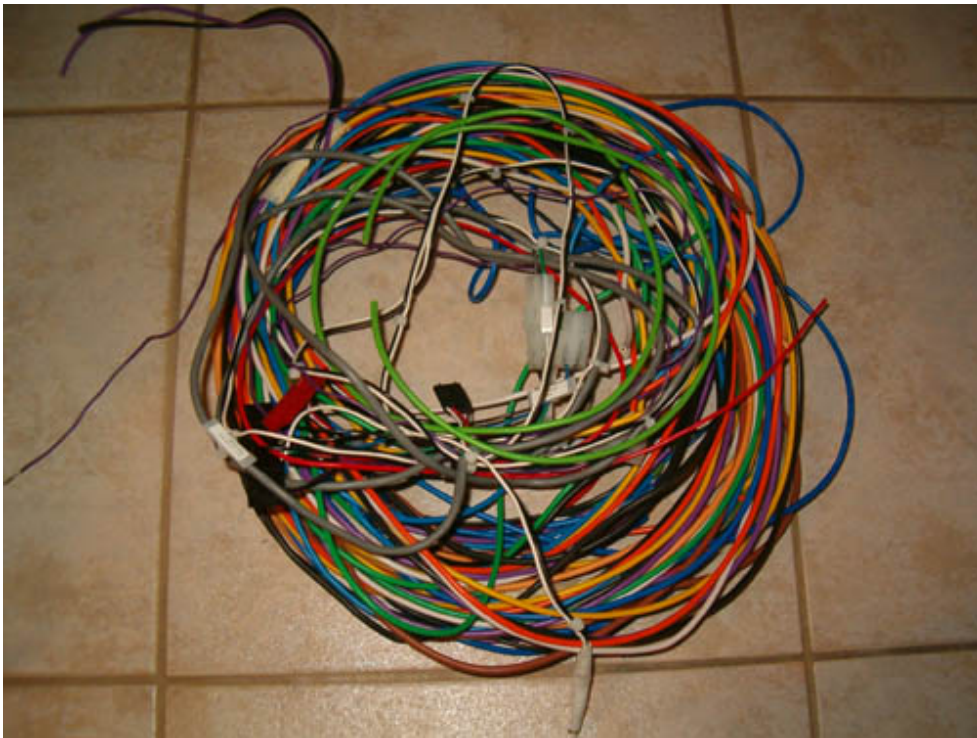
New cables which will replace the old, melted ones.

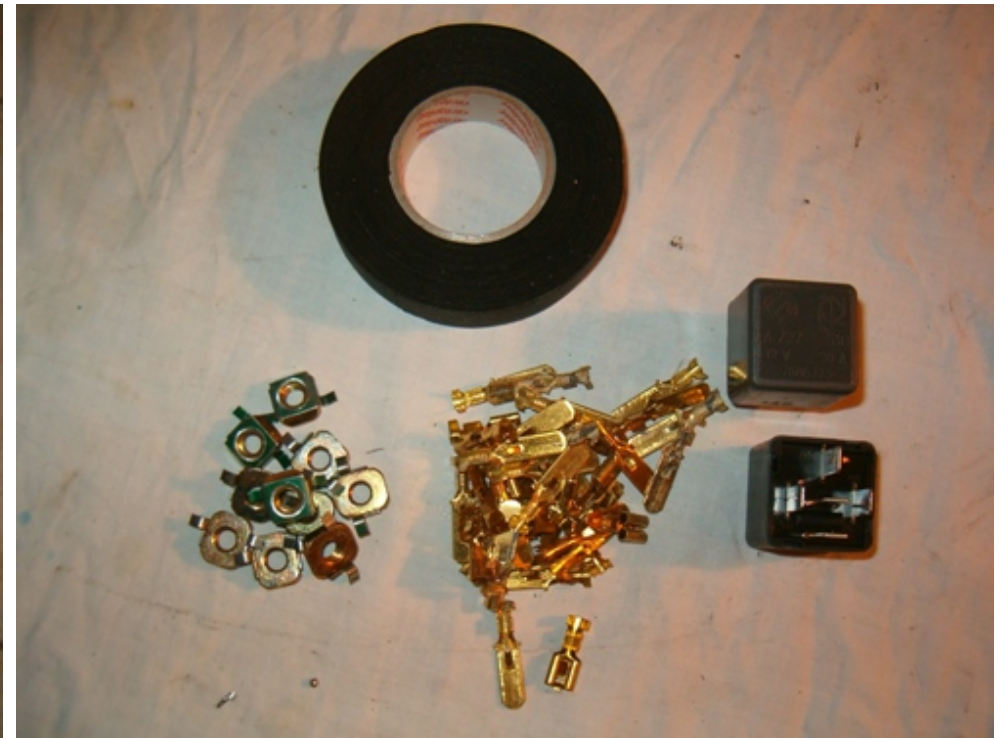
Cloth tape along with new spade connectors and relays. The harness taken from the donor car did not have any relays, so I got two new ones from Alfa. Notice the nuts on the left; these are special nuts from Alfa, required to keep in place pipes etc.

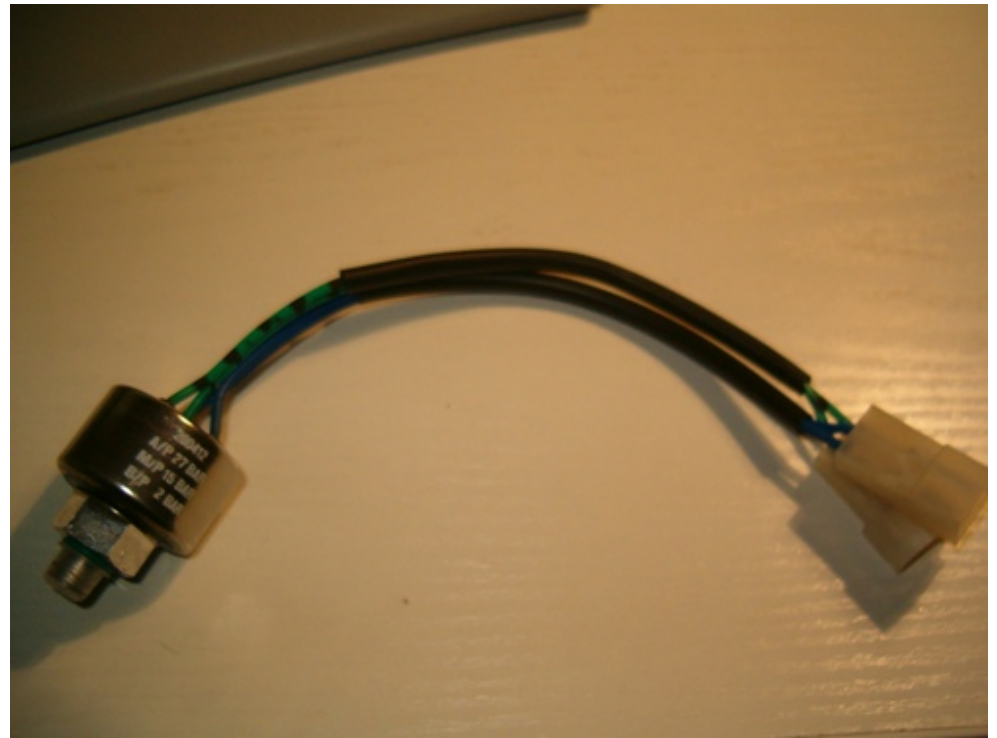
New Trinary Valve. Its purpose is to trigger right side condenser fan and in the meantime it serves as a minimum/maximum pressure switch in the case of a malfunctioning subsystem of the A/C unit (compressor or condenser fan). It is installed on the drier filter in order to measure system pressure and act on each case.
