Hoses rebuilt / restoration

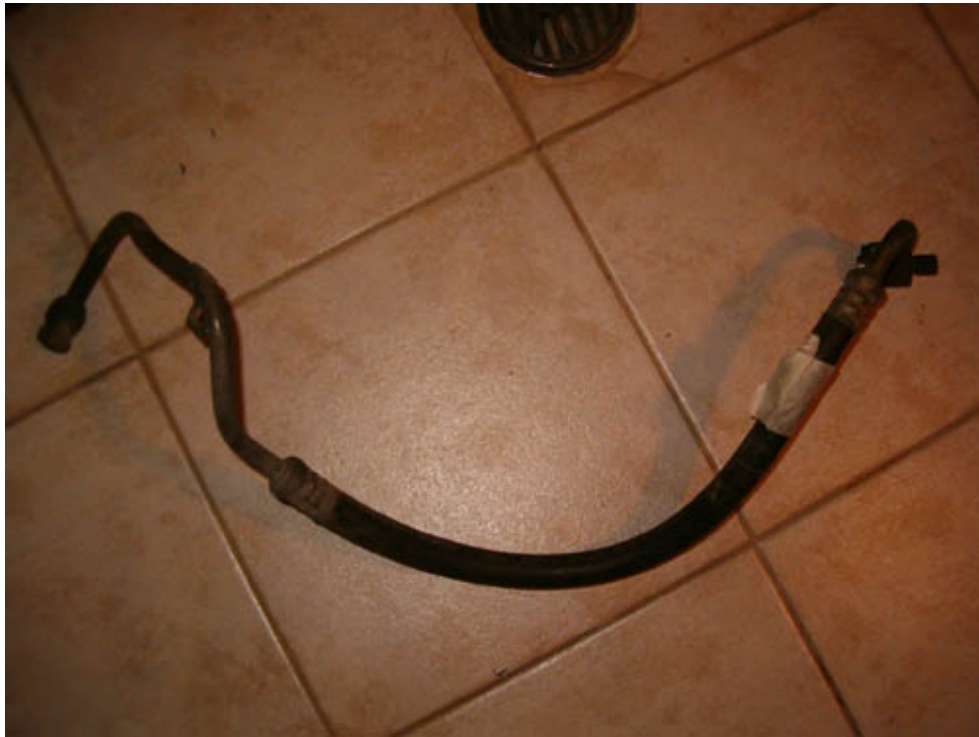
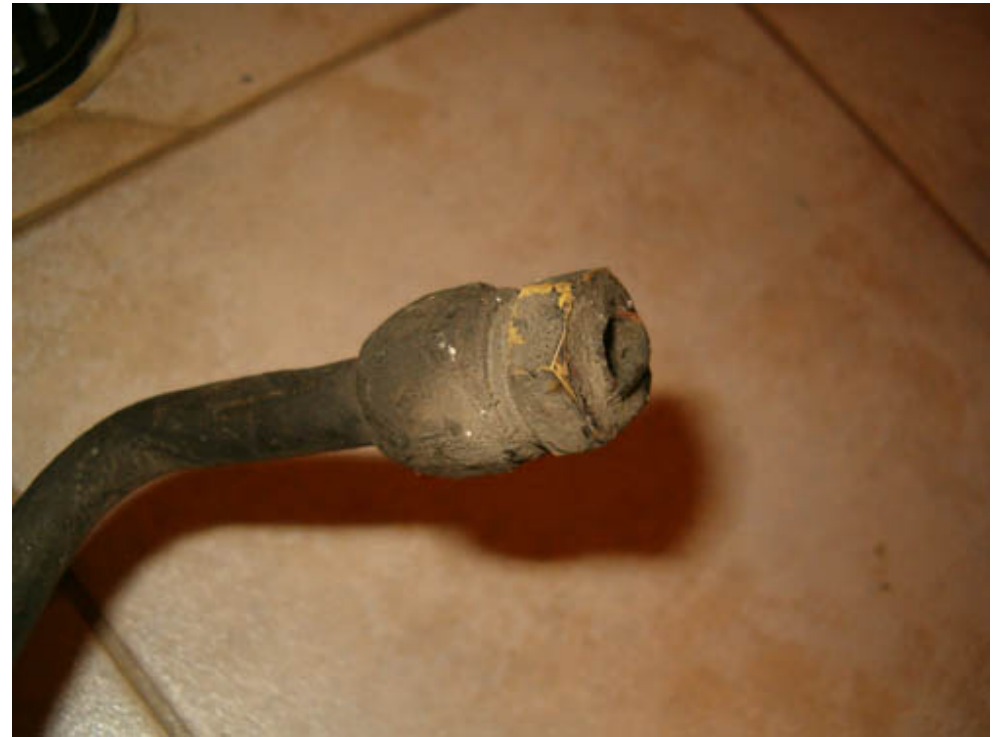
Here you see the hose running from compressor to left condenser. It survived the accident and portion of the condenser was left over

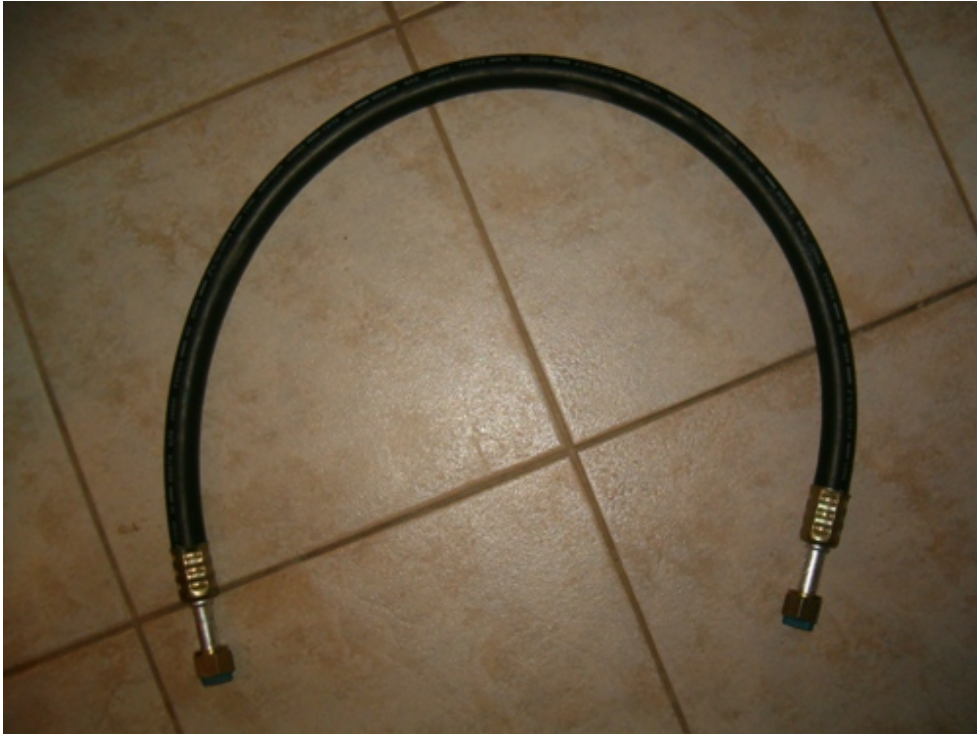
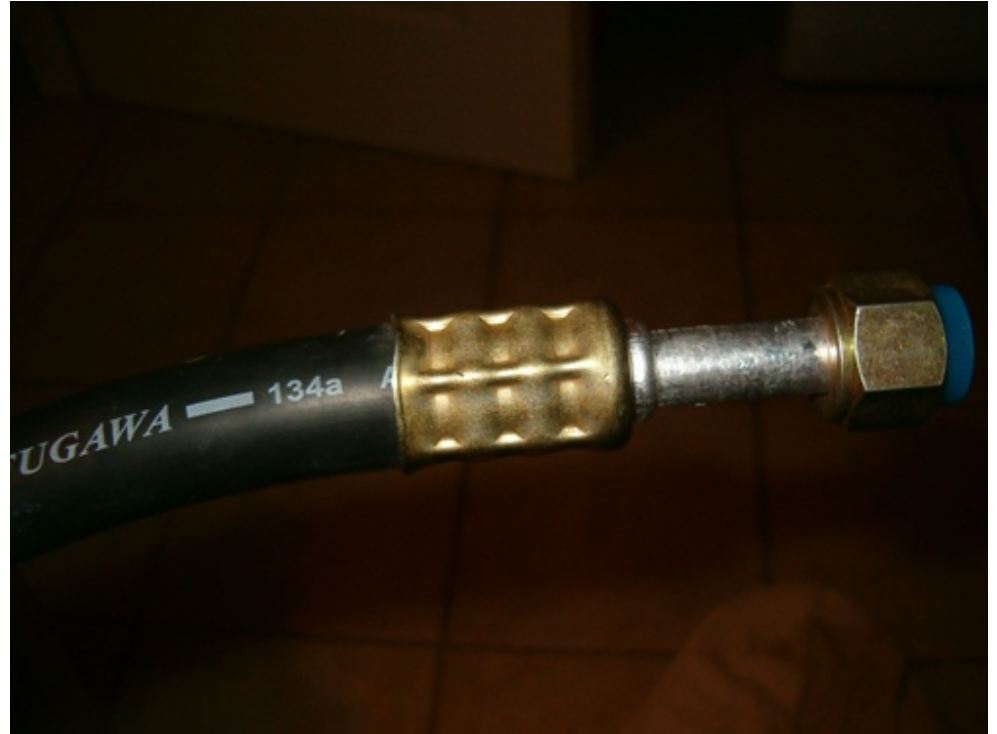
Newly manufactured hose connecting left and right condenser. Notice the designation for use with R134a

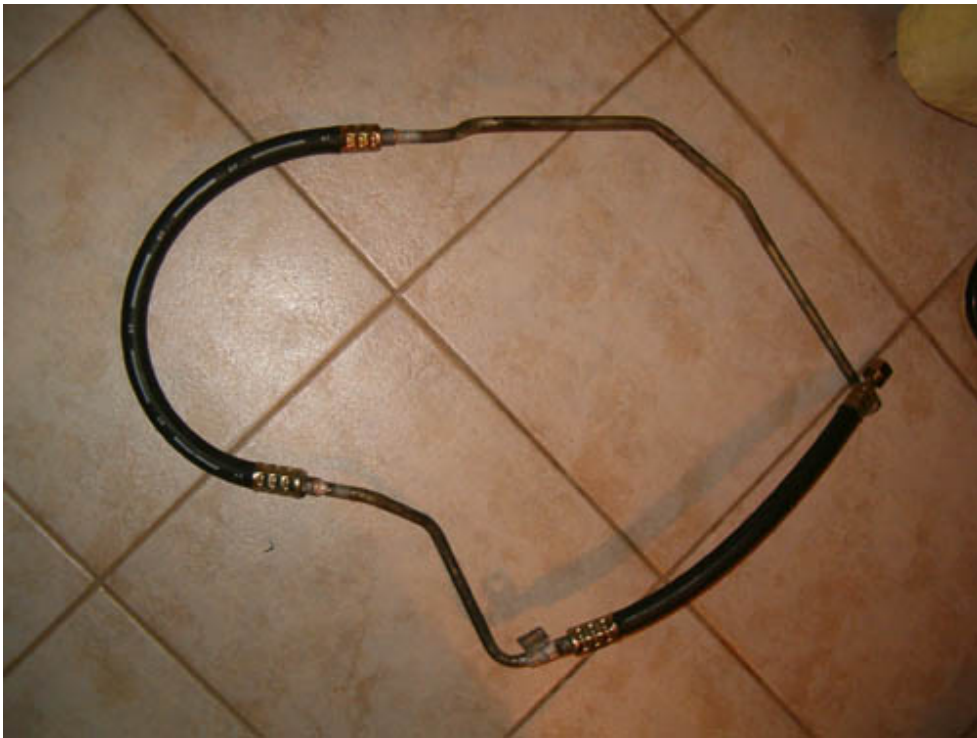
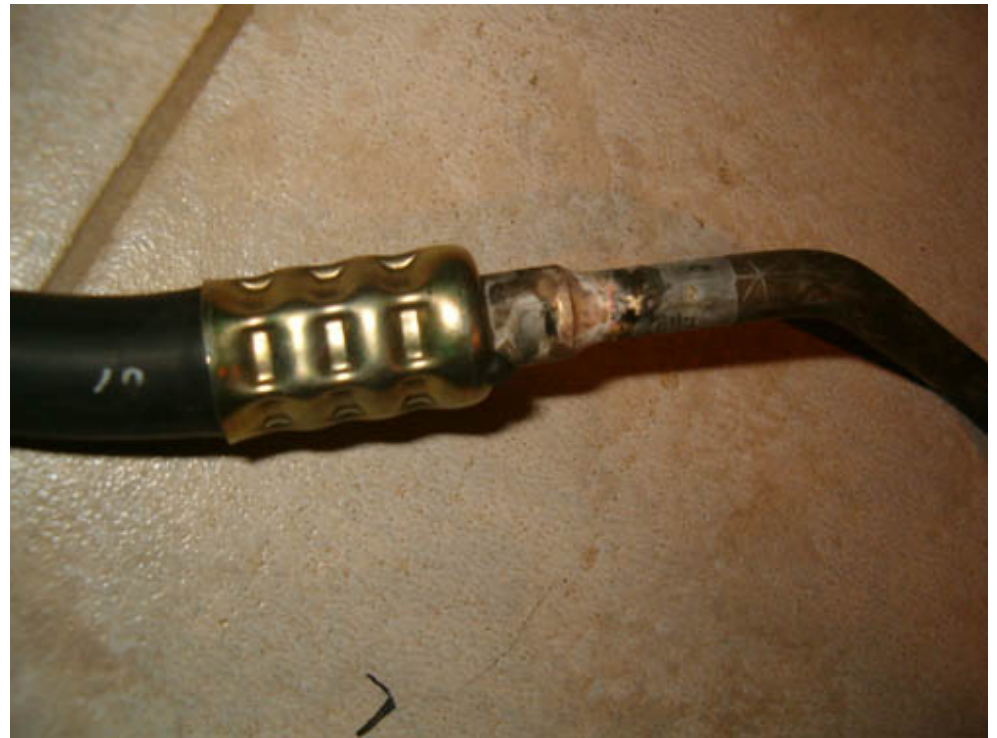
New hose connecting right condenser to drier filter.

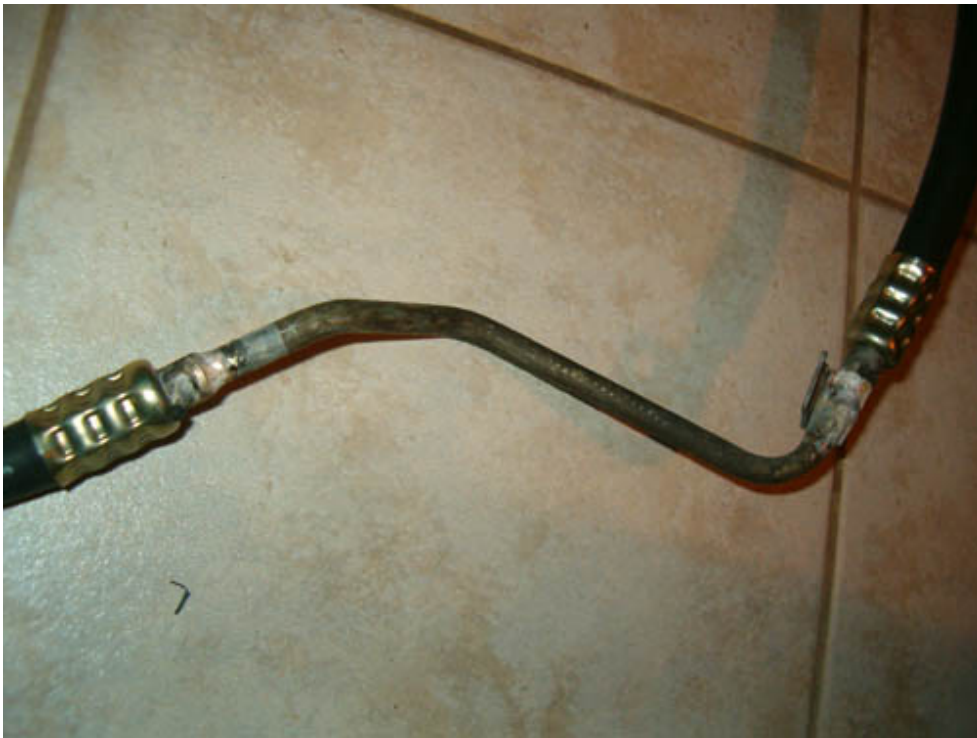
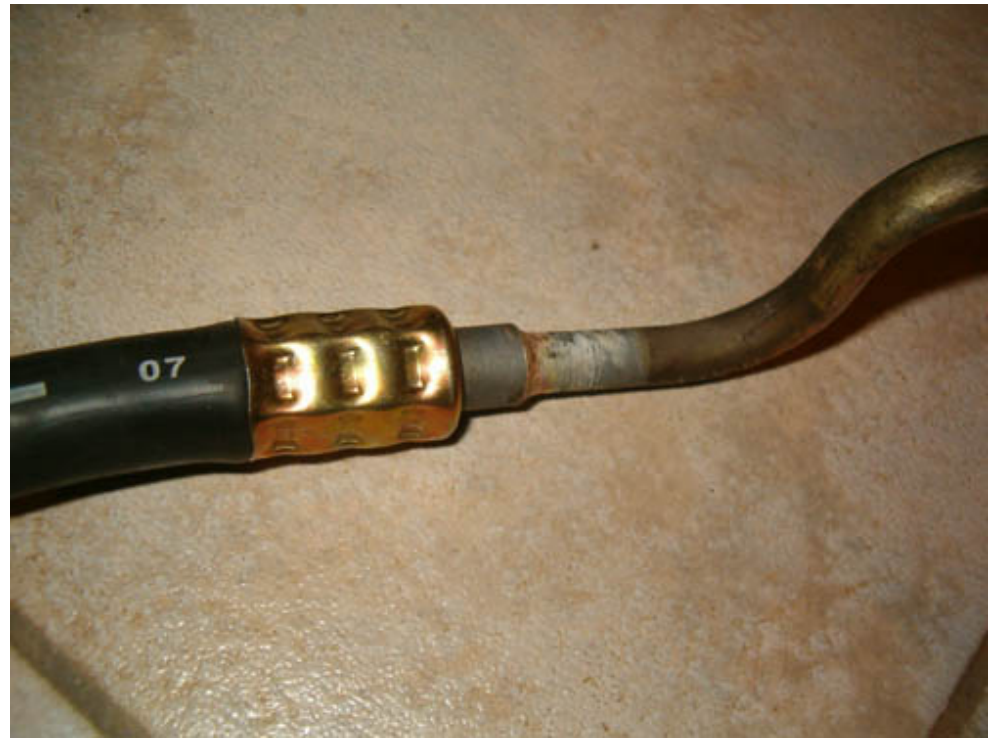
The metal pipe from the original hose was preserved and new R134a hose was used. Notice the welding done in order to adopt new hose and old pipe

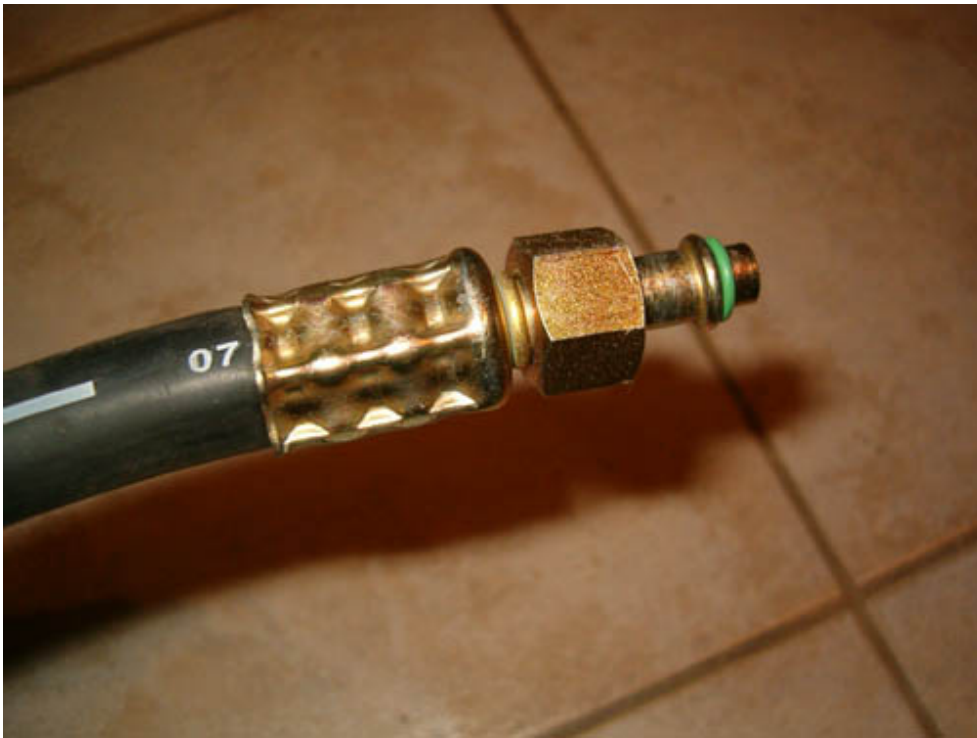
Close up of the new fitting hydraulically crimped to the hose. It surely looks like new.

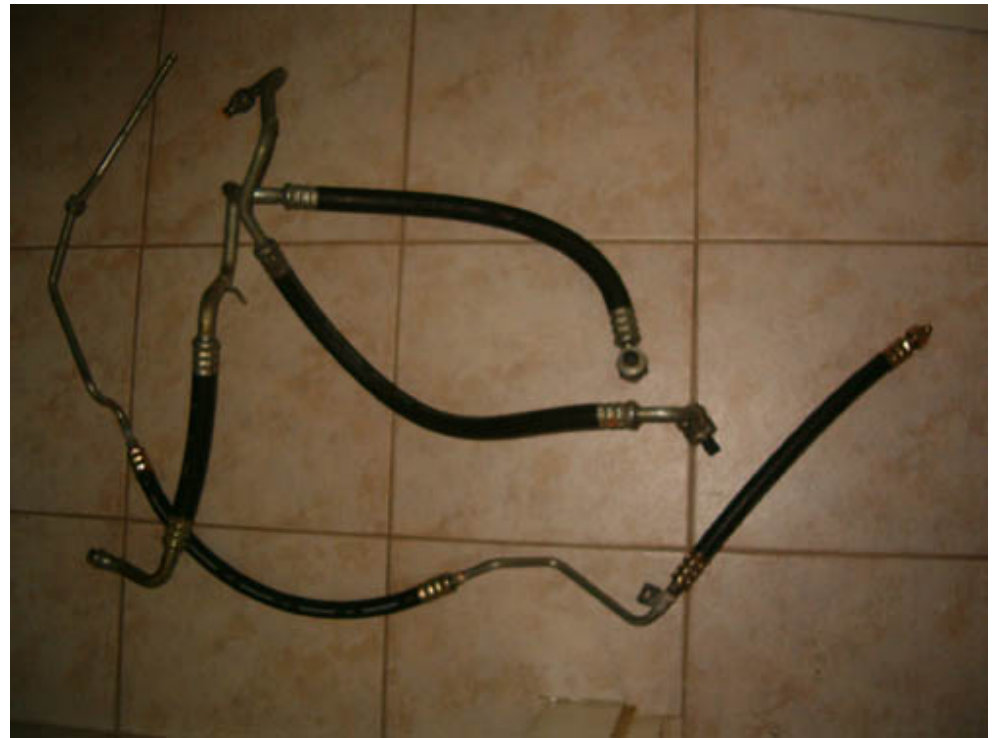
Overview of the hoses. Not showed on the photo is hose running from drier filter to evaporator.
