Ventilation Restoration (Alfa 33 series 907)

Bulkhead Repair

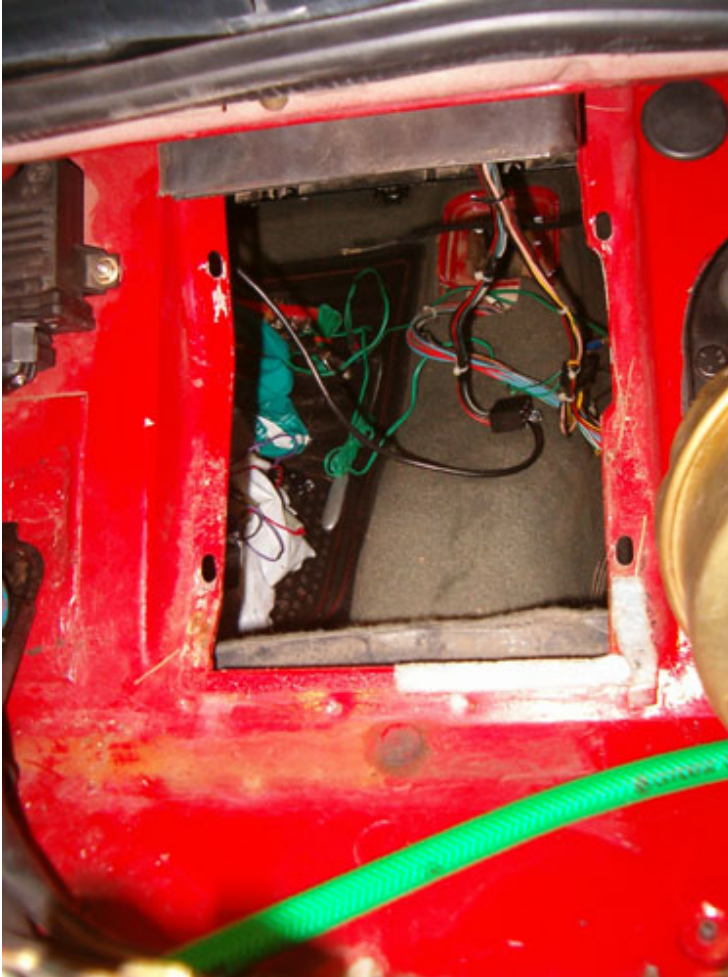
Here you can see the bulkhead without the heater unit. Notice the brown deposits which are traces of coolant along with some minor surface rust.

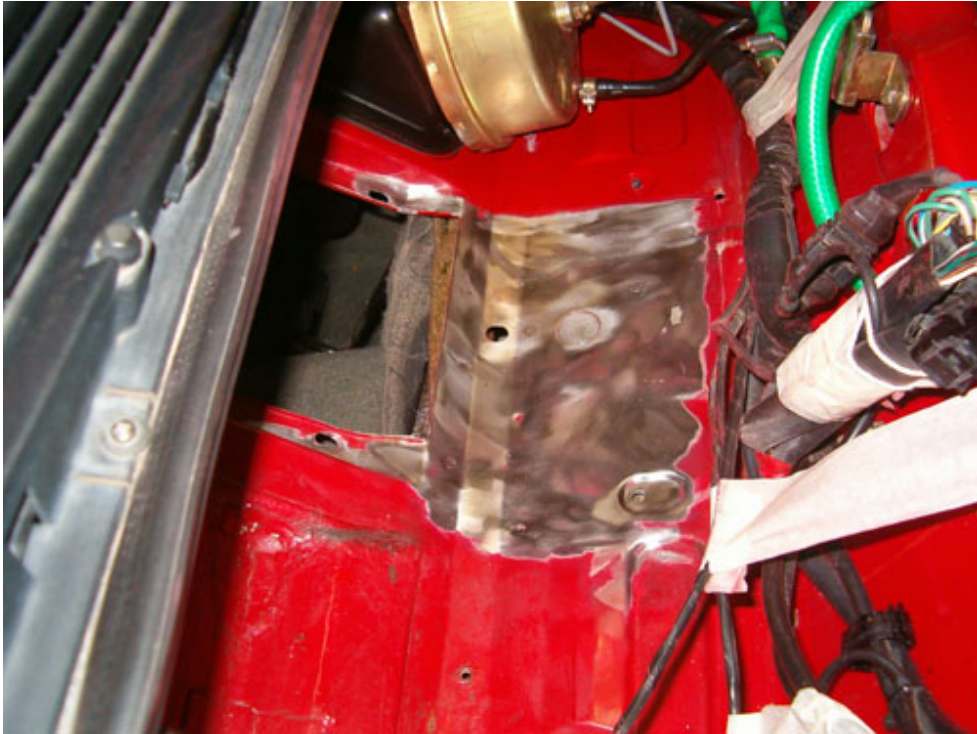
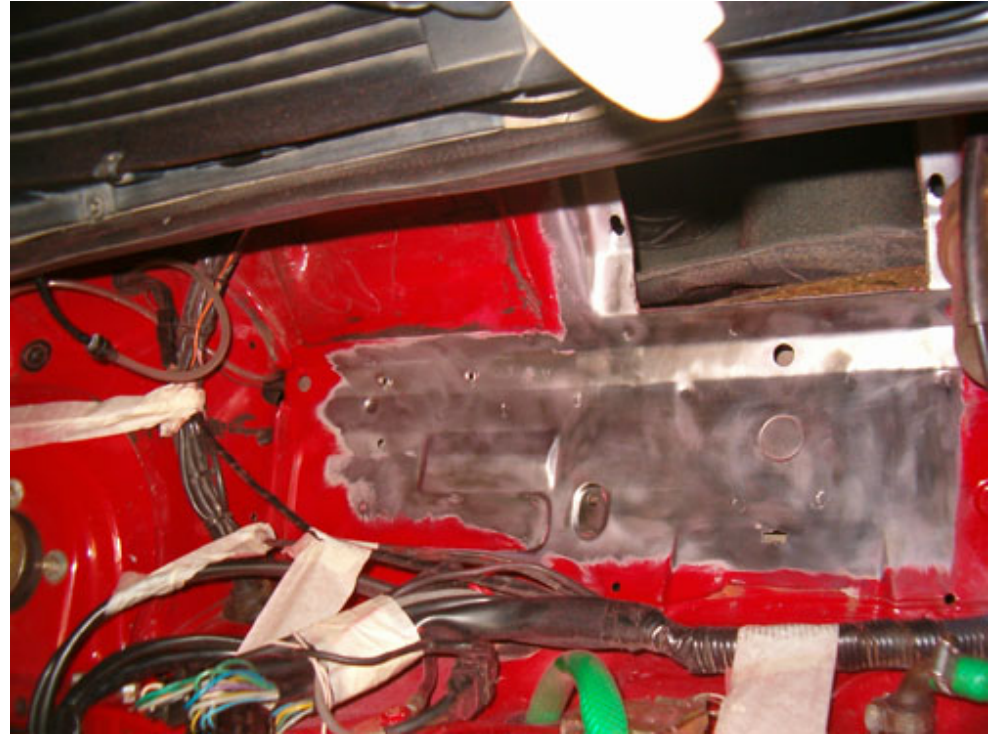
Shown from another angle. I have removed every plastic keeper of cable harness etc. in order to paint only metal. It would be aesthetically awful to see keepers, cable harness over-sprayed ...

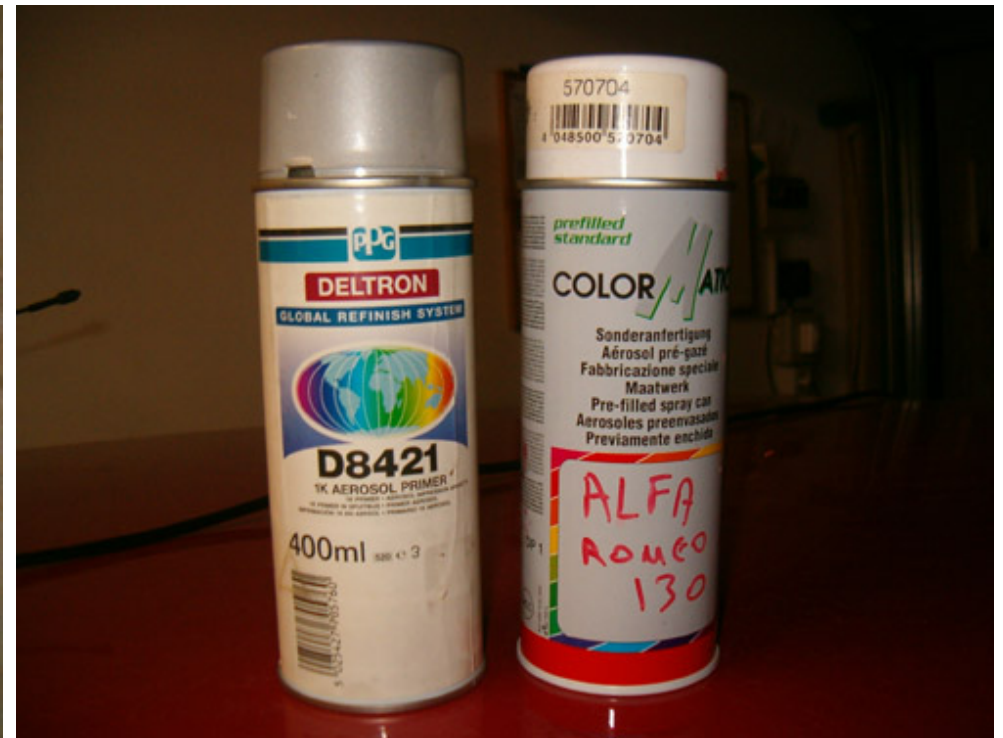
Primer and paint used in the repair.
