Let's now move on in repairing the ABS sensors and do some maintenance to the handbrake lever. It looks like the front left wheel well had been affected by an engine fire. The engine bay had some melted pipes and it seems that the high temperature affected the ABS sensor insulation. It was melted and I had to find a solution.

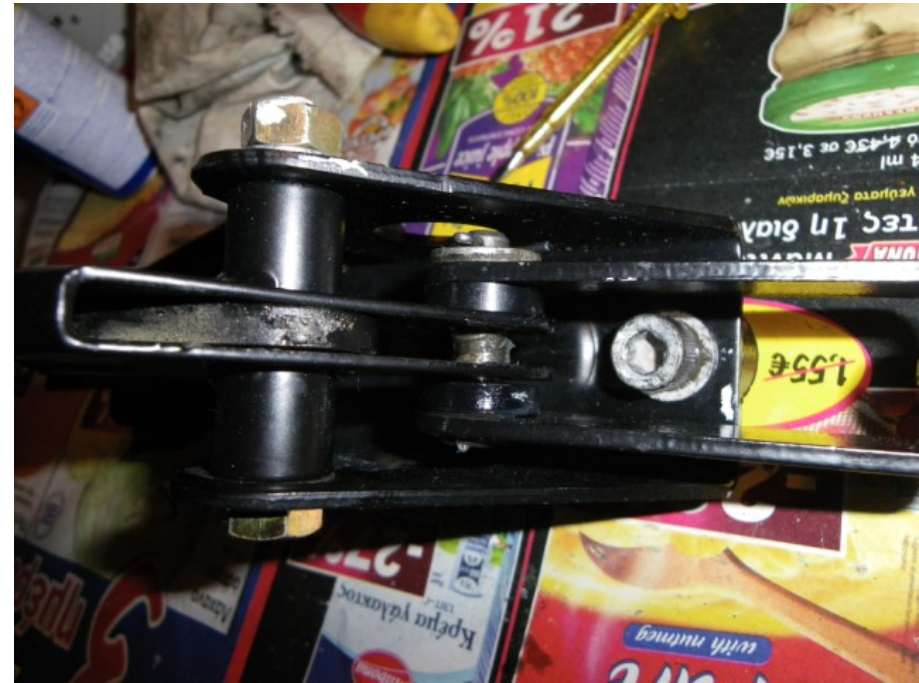
View from the top after the lever is fully attached to the support bracket.

I have used the outer hole as a first approach. However, after the installation I chose to put the lever on the inner hole as it provided better locking of the handbrake.
